Magnolia Marine Transport Tank Barge MM53 Case Study January 2006

**Jim Smith – Magnolia Marine Transport
Andrew Milanes – Environmental Science
Services, Inc.**

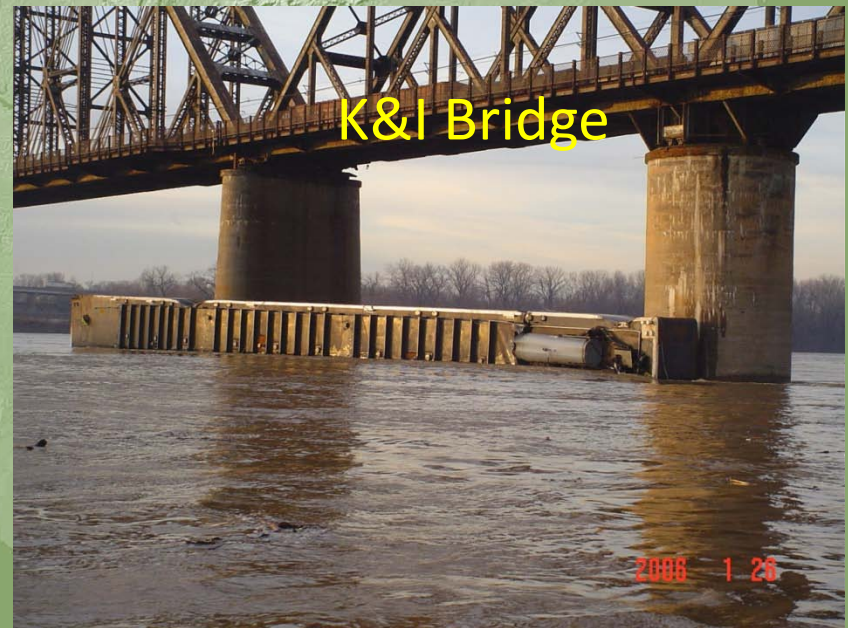
- The barge begins taking on water on the port side due to the high current.
- The force on the port side eventually flips the MM53 90 degrees, and is pinned between the piers.

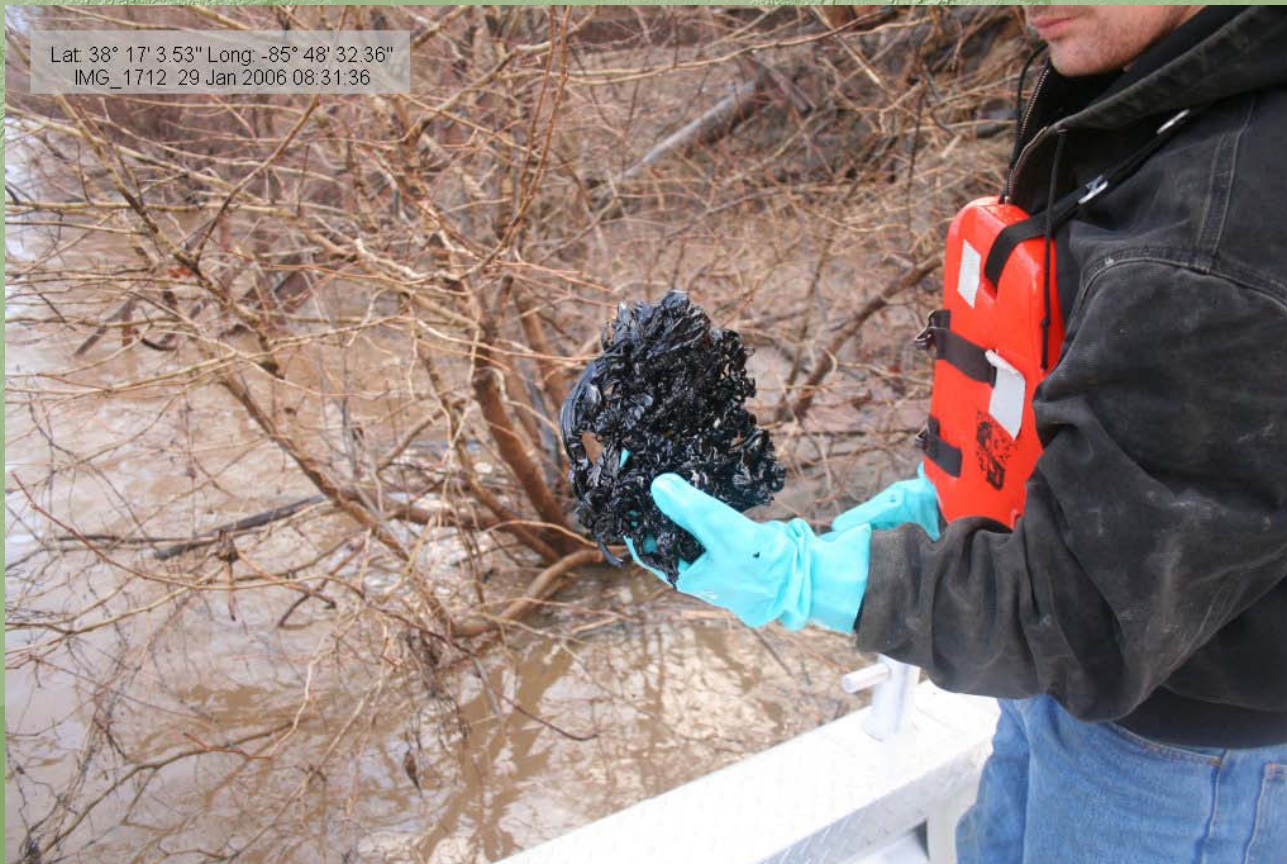
“Funnel Cake”

- 6-12” diameter, 1” thick extruded patty
- Significant air entrainment and voids allowed product to float.

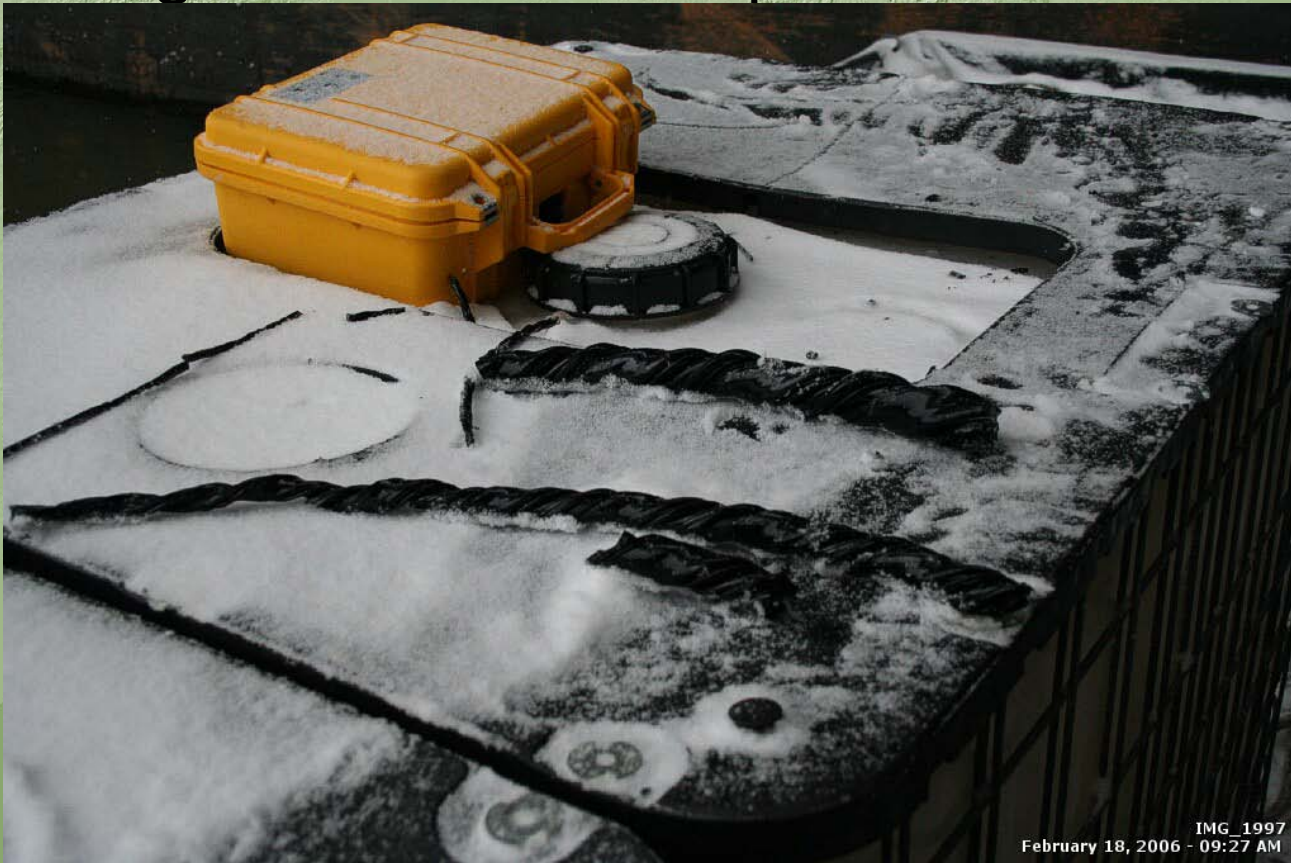
"Icicle"

- ½-1" diameter, 1-4' long extruded strand.
- Minimal air entrainment provided for submergence after a short period of time.

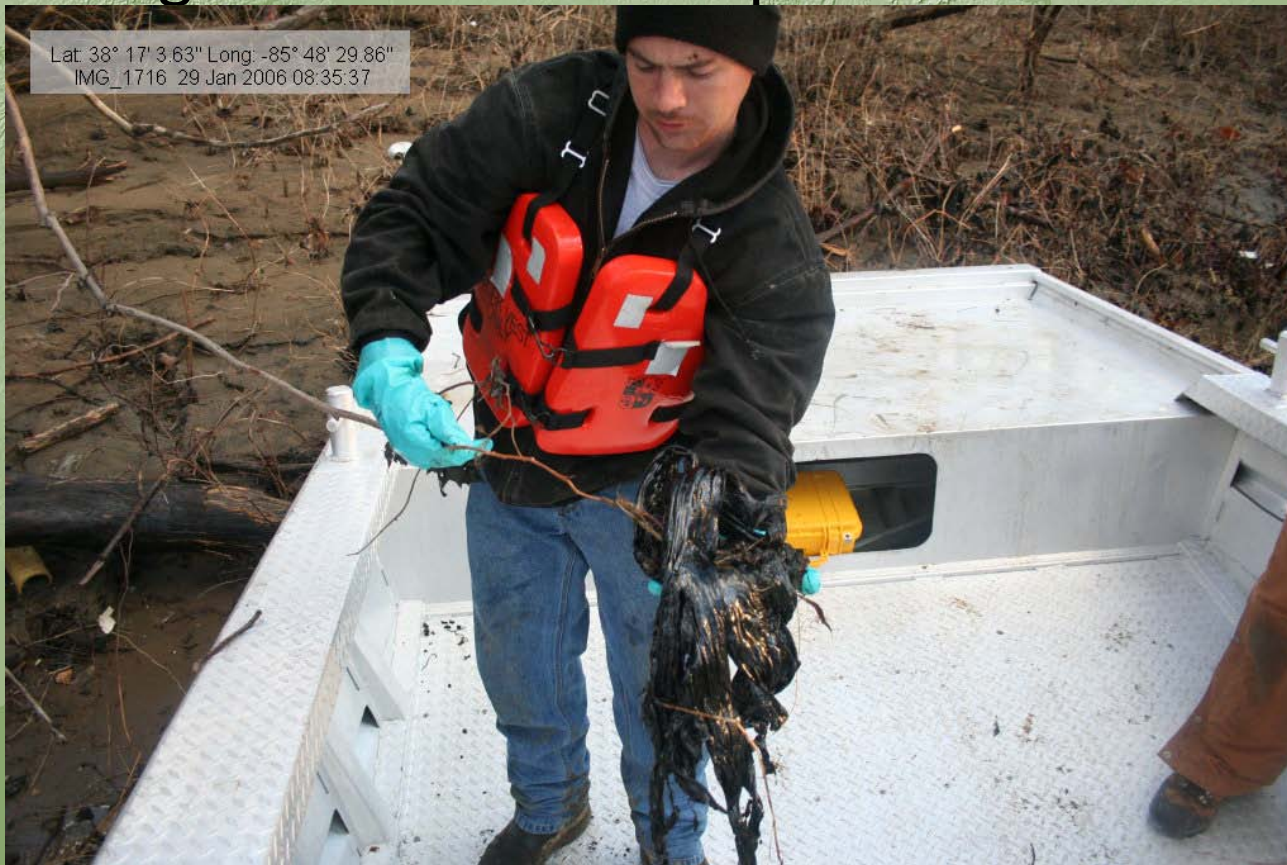
“Taffy”

- Entangled strands of extruded asphalt.
- Minimal air entrainment provided for submergence after a short period of time.

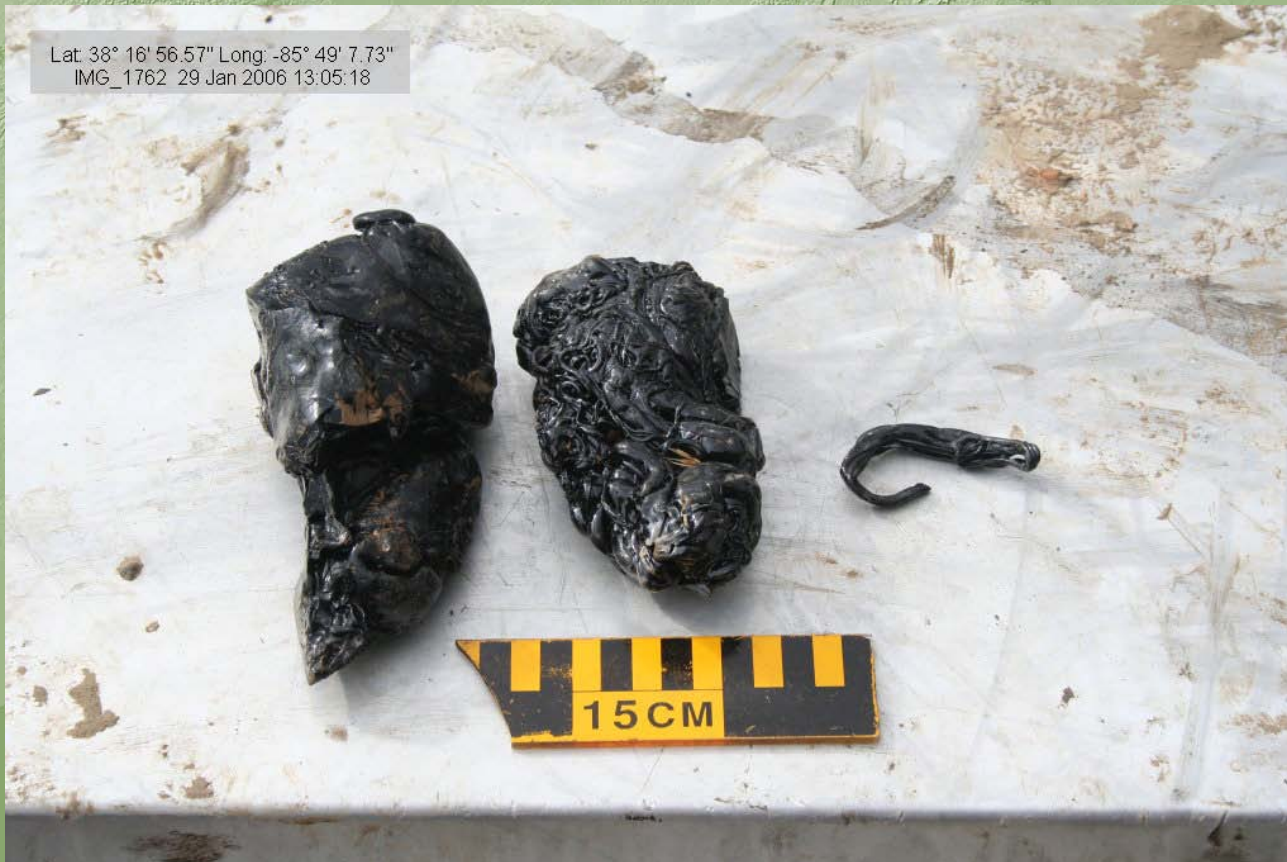
“Barge Droppings”

- Accumulations of extruded asphalt.
- Formed when product collected on the river bottom and rolled downriver with the current.

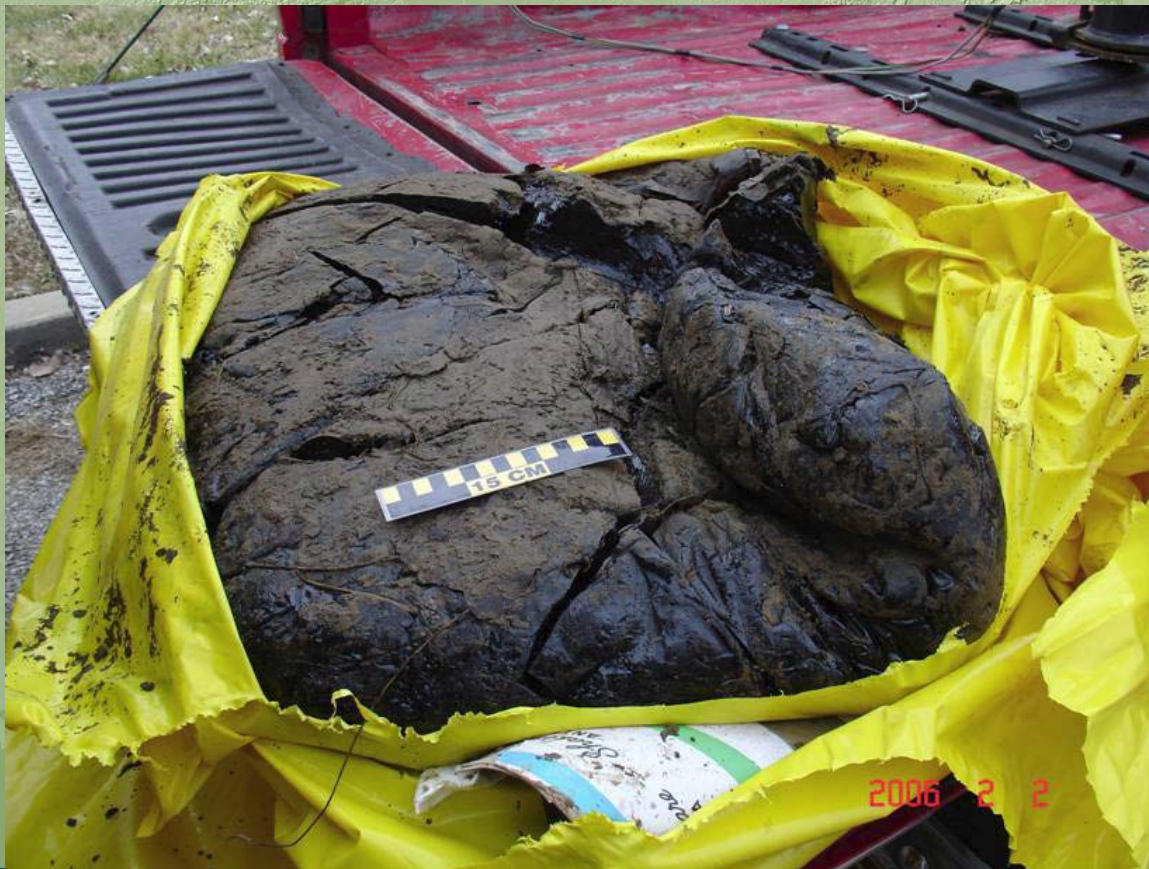
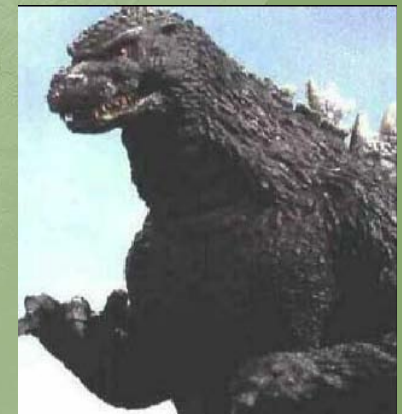
“Pancake-Zilla”

- Mother of all Barge Droppings!
- Found over one mile from the barge, 15 feet up the bank.

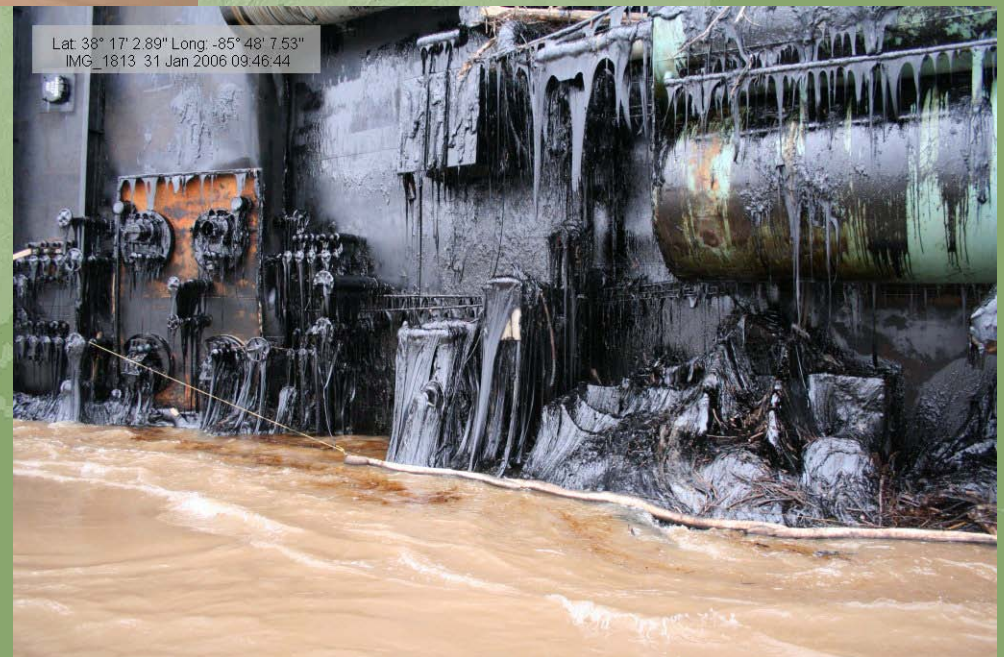
Thermal Heating Oil Release

- 5,000 gallons of diesel were released from the port tank almost immediately when the barge flipped 90°.
- 4,000 gallons of thermal heating oil was released from the damaged heating coils.
- Small amounts of heating oil continued to leak from the damaged piping for about a week.

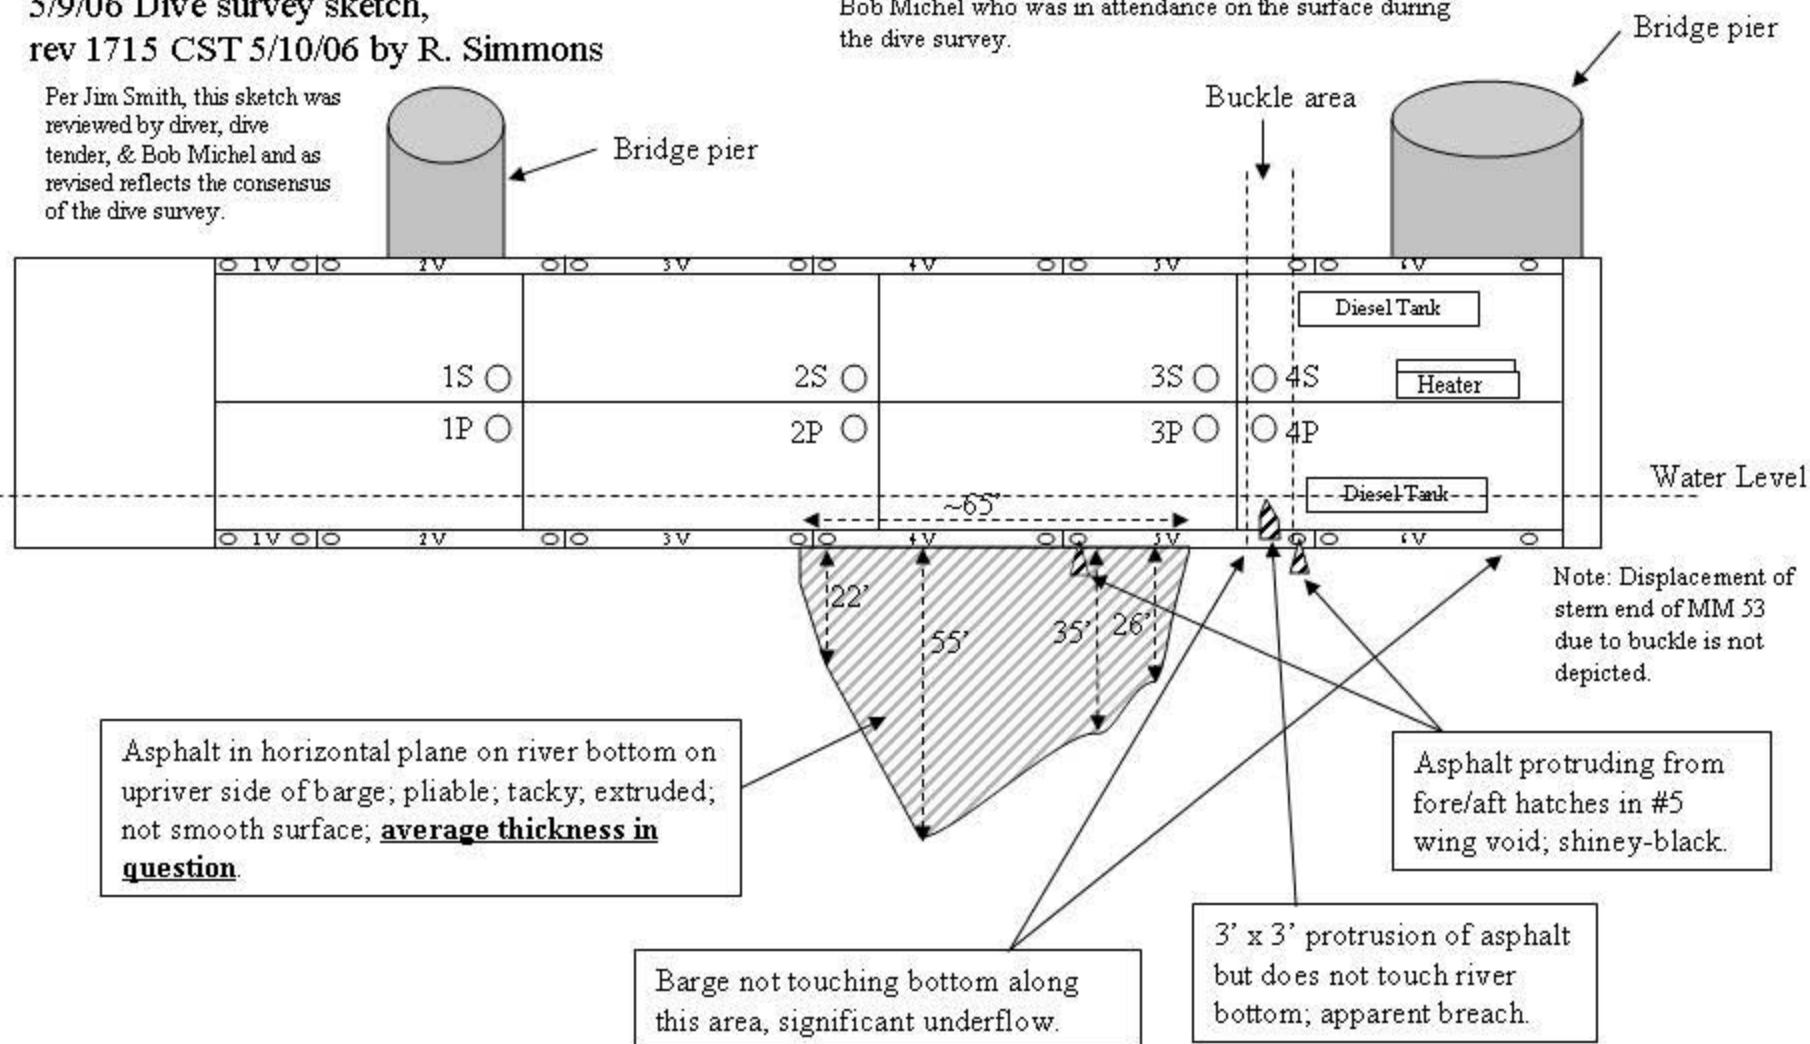
MM 53 – roughly to scale
5/9/06 Dive survey sketch,
rev 1715 CST 5/10/06 by R. Simmons

- Dive survey was conducted to determine location and quantity of asphalt on river bottom, in front of the barge.
- Large asphalt mat located in front of barge – thickness unknown.

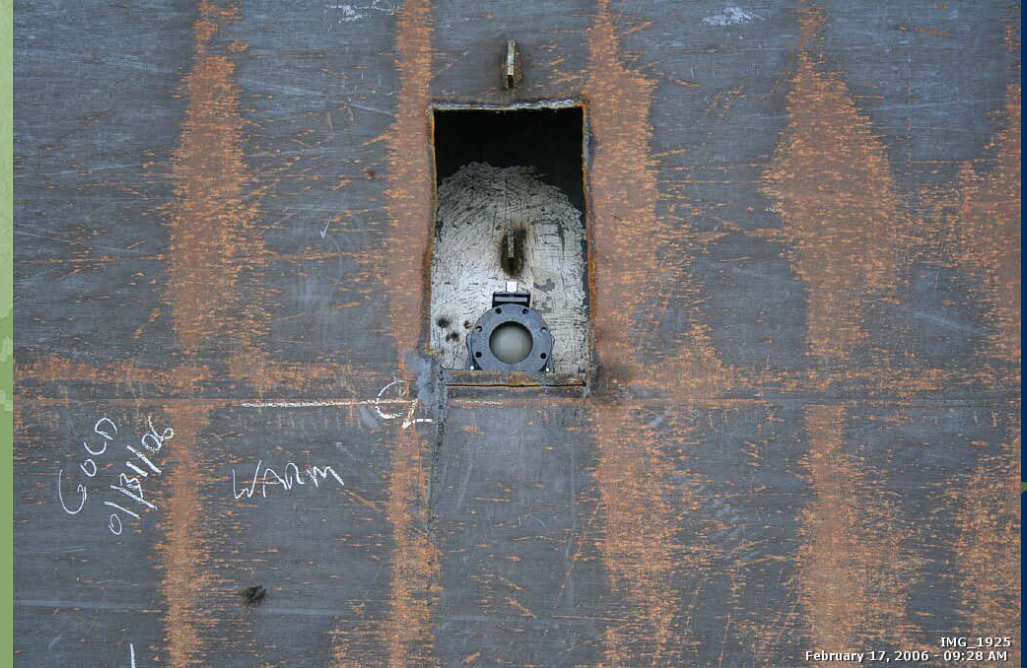
IMG_1925
February 17, 2006 - 09:28 AM

“Windows” cut into
bottom of MM53
for cargo lightering.

- Cut windows in bottom (back side) of barge to install valves into cargo compartments.
- Use these new valves to drain reheated cargo into the MM54B.

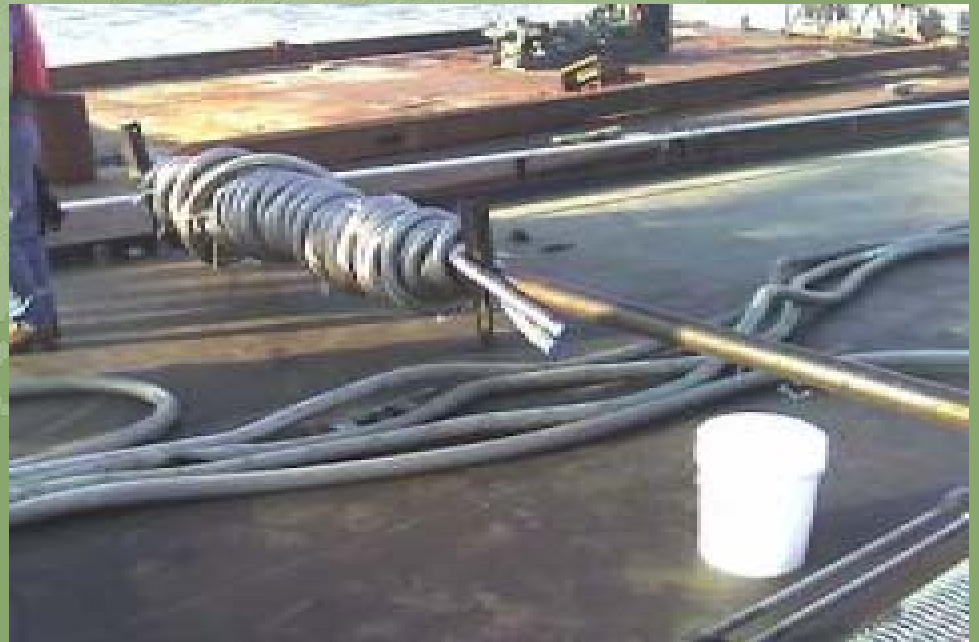
- Heating coils in #4 port compartment were compromised.
- A “stinger” was constructed to heat the compartment.
